The Fire Resistance Performance of a Loadbearing Timber Floor Assembly Protected by a Plasterboard Ceiling Designed to Provide 30 minutes Fire Resistance, Incorporating Twenty Three Downlight Fittings, When Tested Accordance with BS EN 1365 - 2: 2014

WF Report No: 385023-B

388542A Issue 2

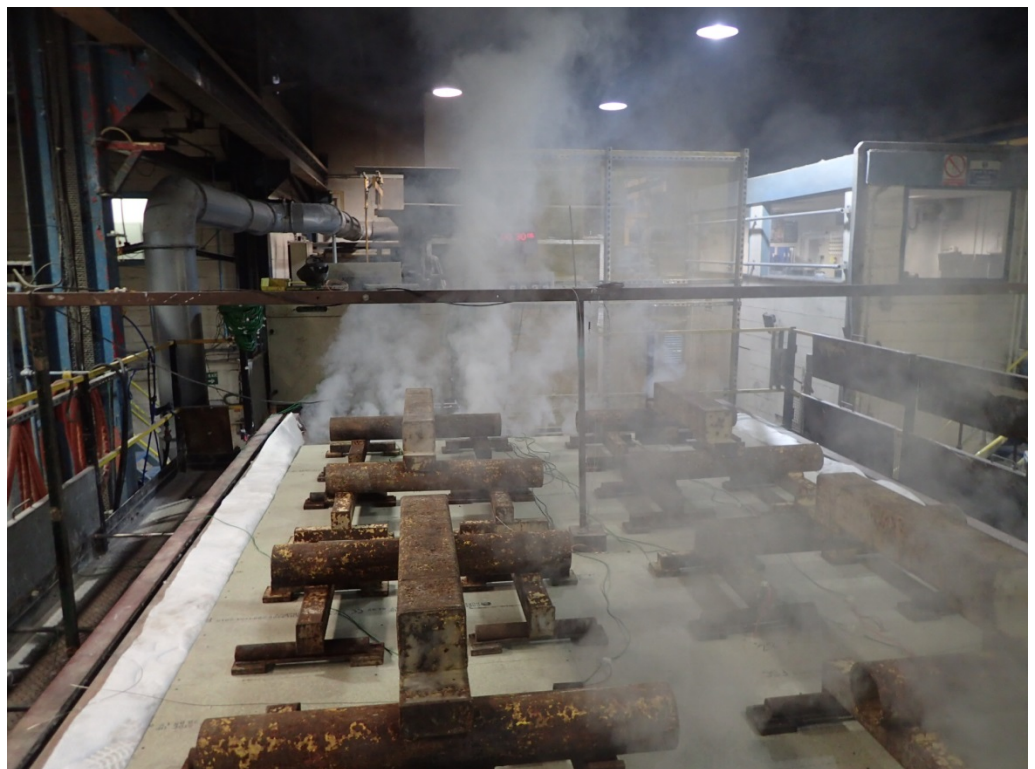
The unexposed surface of the assembly after a test duration of 30 minutes

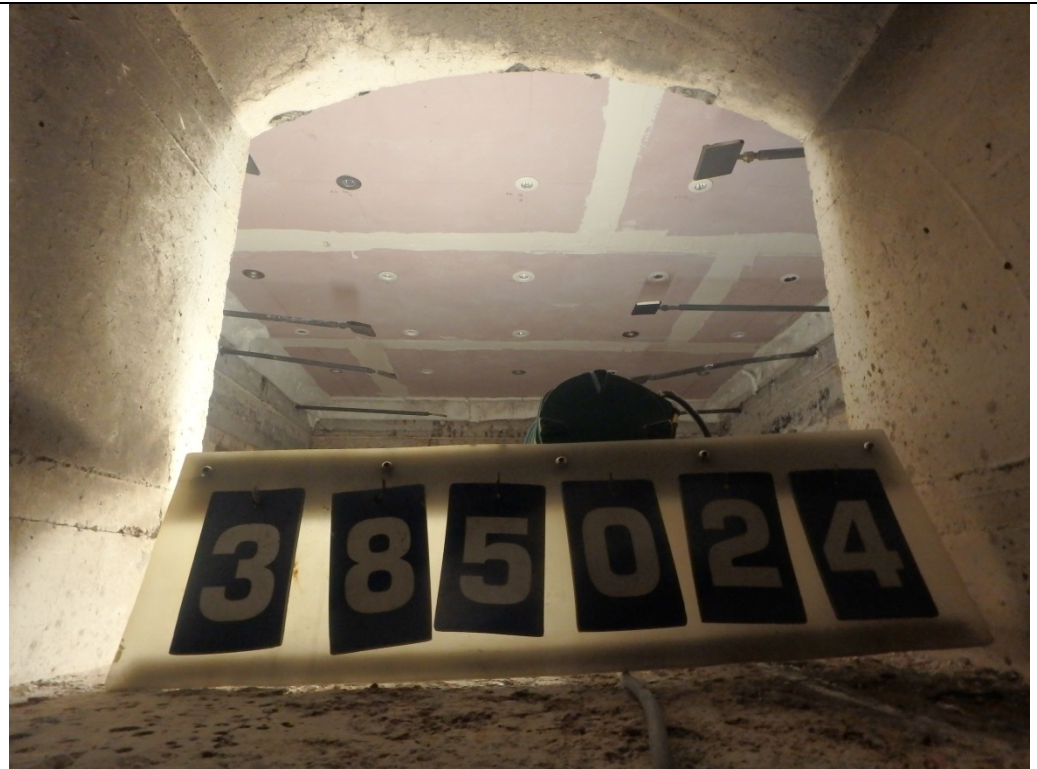
The exposed face of the assembly prior to the start of the test

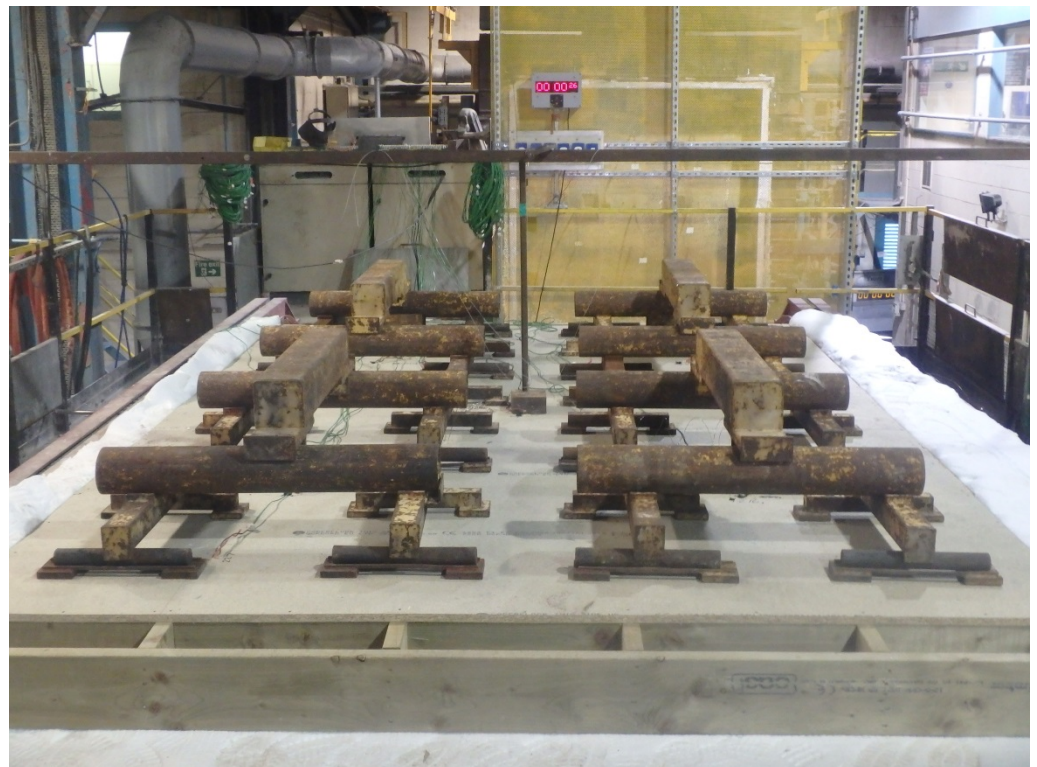
The unexposed face of the assembly prior to the start of the test
