The Fire Resistance Performance of a Loadbearing Timber Floor Assembly Protected by a Plasterboard Ceiling Designed to Provide 30 minutes Fire Resistance, Incorporating Twenty Three Downlight Fittings, When Tested Accordance with BS EN 1365 - 2: 2014

WF Report No: 385023-B

Integral LED

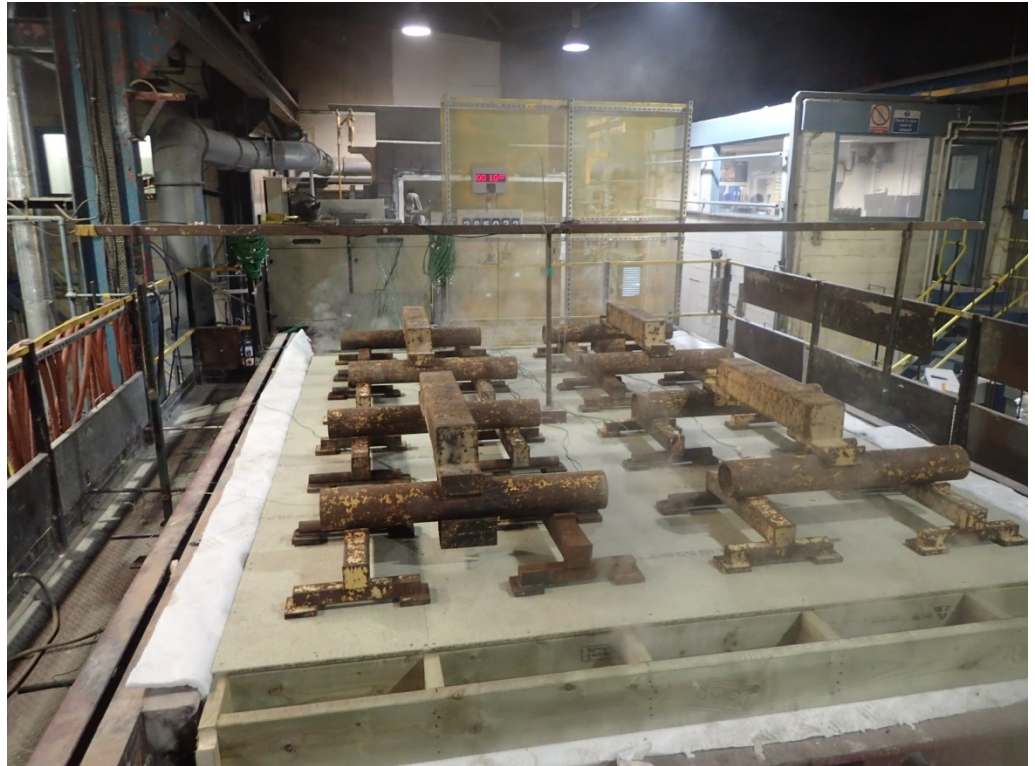
The unexposed face of the assembly after 10 minutes of testing
