The Fire Resistance Performance of a Loadbearing Timber Floor Assembly Protected by a Plasterboard Ceiling Designed to Provide 30 minutes Fire Resistance, Incorporating Twenty Three Downlight Fittings, When Tested Accordance with BS EN 1365 - 2: 2014

WF Report No: 385023-B

The Fire Resistance Performance of a Loadbearing Timber Floor Assembly Protected by a Plasterboard Ceiling Designed to Provide 60 minutes Fire Resistance, Incorporating Twenty Three Downlight Fittings, When Tested Accordance with BS EN 1365 - 2: 2014

388542A Issue 2

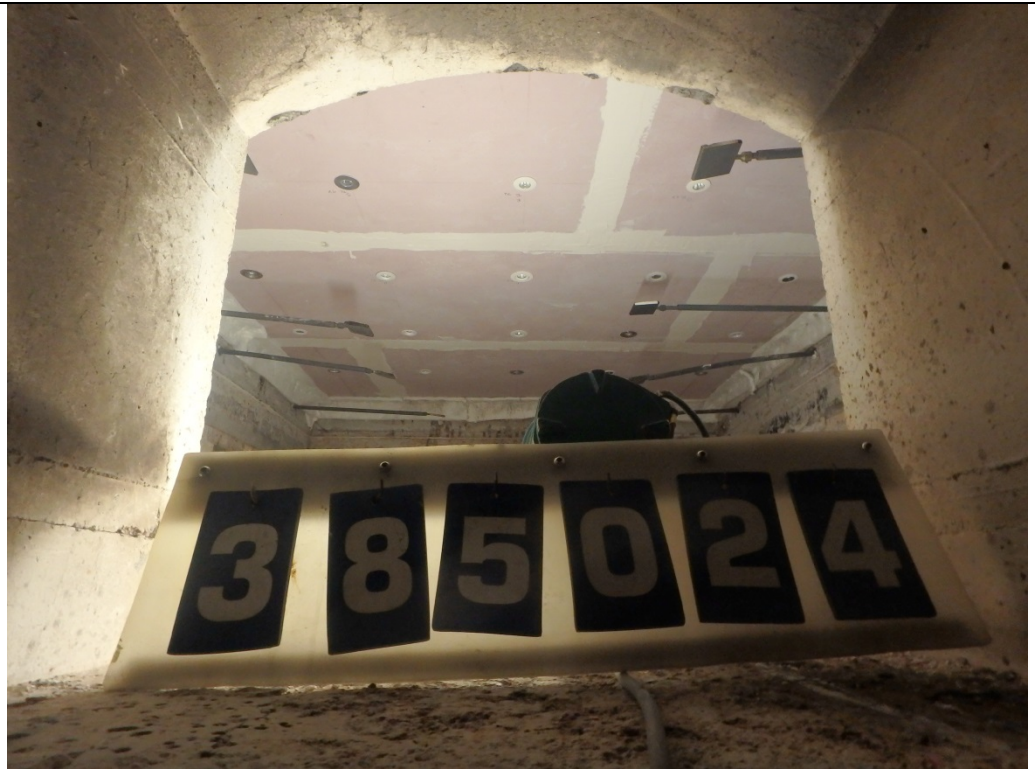
The exposed face of the assembly prior to the start of the test
